Clerkin Higgins Stained Glass recently undertook a stained glass conservation project at Stanford Memorial Church on the campus of Stanford University

# Conserving J&R Lamb's Beautiful Stanford Windows

By Mary Clerkin Higgins

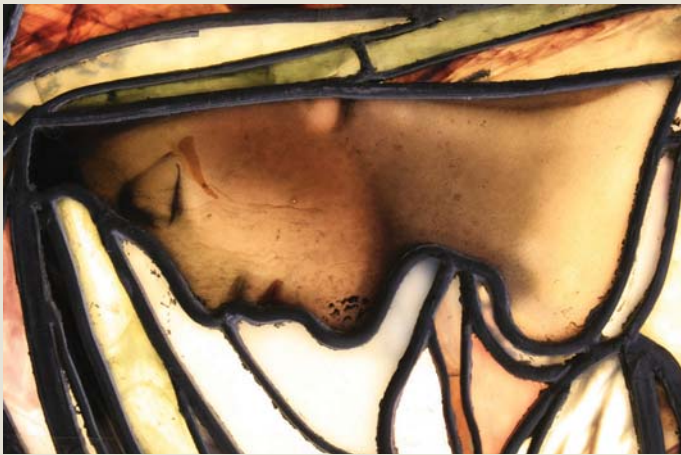
THIS PAGE, CLOCKWISE FROM TOP LEFT:  
 Frederick James Shields (1833-1911), **The Annunciation**, 1894, oil painting, Manchester Art Gallery.  
 Frederick Stymetz Lamb, Lamb Studios, **The Annunciation**, 1903.  
 Frederick Stymetz Lamb, **The Annunciation**, detail showing dirt trapped between the plates.

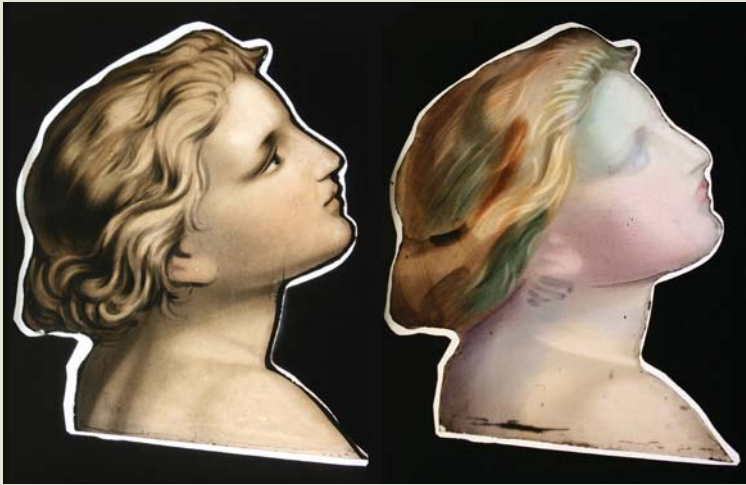
The inside plate is white glass with mainly black and brown paint and the outside plate is clear, hammered glass painted with enamels and silver stain.

Very little of the glass was painted -mainly the flesh and inscriptions—and that paint was in very good condition—well fused to the glass surface. The flesh pieces were two layers, both of which were painted. The front/interior layer was white opalescent glass painted primarily with black and brown paint, as well as some colored-enamel washes. The exterior layer was clear rolled glass painted primarily with colored enamels.

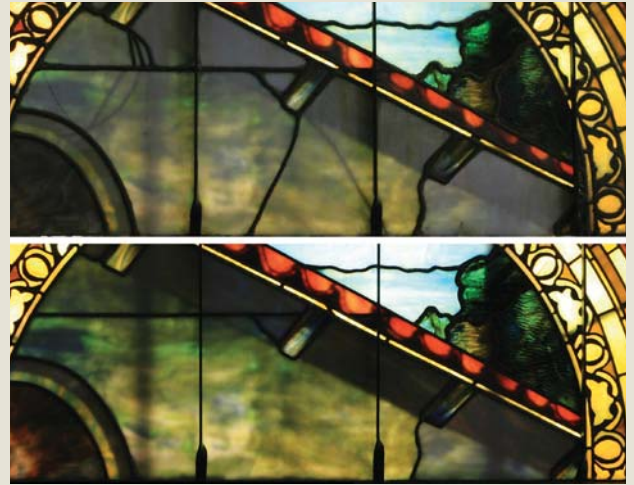
It was possible to eliminate a number of lead repairs using silicone fill repairs. Top: Before, Bottom: After.

There were several instances where a broken piece of streaky opalescent glass had been grozed (ground) along the break edge to make room for an opaque repair lead. Epoxy fills in streaky opalescent glass are a challenge because the color changes are so frequent and dramatic within one piece of glass. Since Lamb's aesthetic was to have large fields of color not broken up with leads, I eventually decided to try a new way to fill the gaps using colored silicone mixed in small batches to match the varieties of color in one piece of glass, working across the break line.

Silicone fills have been done before, but an innovation that struck me as I started these fills was to use colored glass enamels as the colorants. They are essentially finely ground up glass with great color stability and they mix and bond well with silicone. Most studios have a large range of colors on hand and they are more stable than dyes—though dyes work better when matching transparent blown glasses. My goal was to match the

glass color in transmitted light. The panels' additional layers of plating help hide the fill. Wherever the silicone fill was to be exposed to the elements it was protected with a clear exterior glass plate that had a little texture on it (i.e. not flat double-strength glass which would be too reflective). The edges of any pieces with silicone fills were sealed and strengthened by filling the gaps between the layers with a small bead of silicone to better hold all the pieces together.

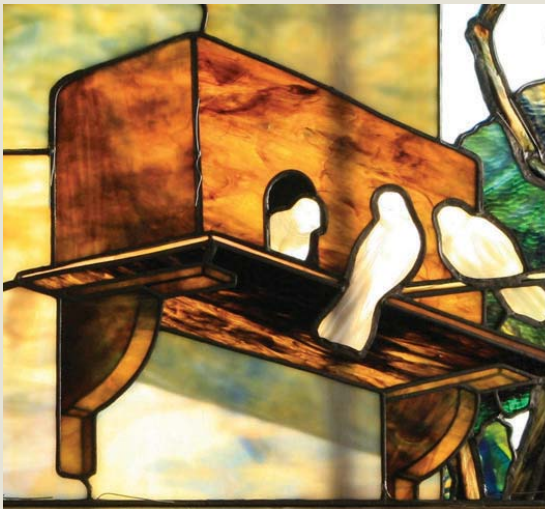
There were numerous instances of extreme cutting. Some survived the years (and earthquakes), while others did not.

One problem Lamb had with faithfully translating a print or painting into stained glass was that some shapes found in the originals are a challenge to achieve in glass. Cutting involves making a series of scratches, or “scores,” on the glass surface to encourage it to break where you want it to. For difficult shapes you have to plan out where to stress it and deep cuts can be very difficult to make—especially without modern-day glass saws or water-jet cutters. While this took a great degree of skill and experience, there’s a long-term danger with extreme cutting—you may be building a vulnerability into the window, leaving it one jolt away from breaking. Or not—but it’s a risk. Some shapes broke, others haven’t, yet. And while any piece of glass can break, we all know some shapes are more vulnerable than others.

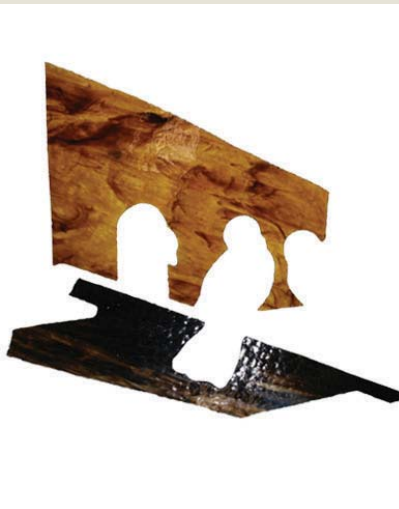
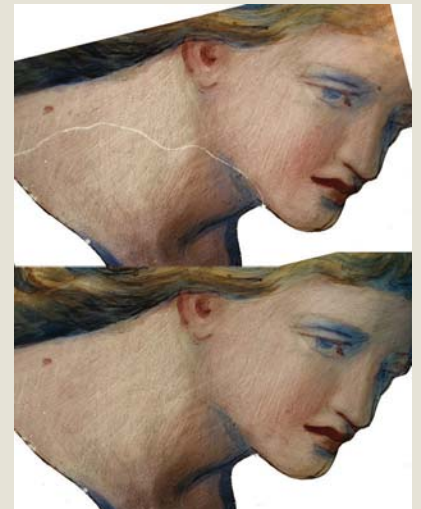
Loss of vitreous paint along glued cracks was inpainted with "cold" paint.

There are almost always chips missing along a break line which must be carefully filled and then in-painted to replace both the missing glass and vitreous paint. There were instances where original paint was missing in small drips and such, and needed to be touched up. These were delicately in-painted using Artist's Alkyd paints

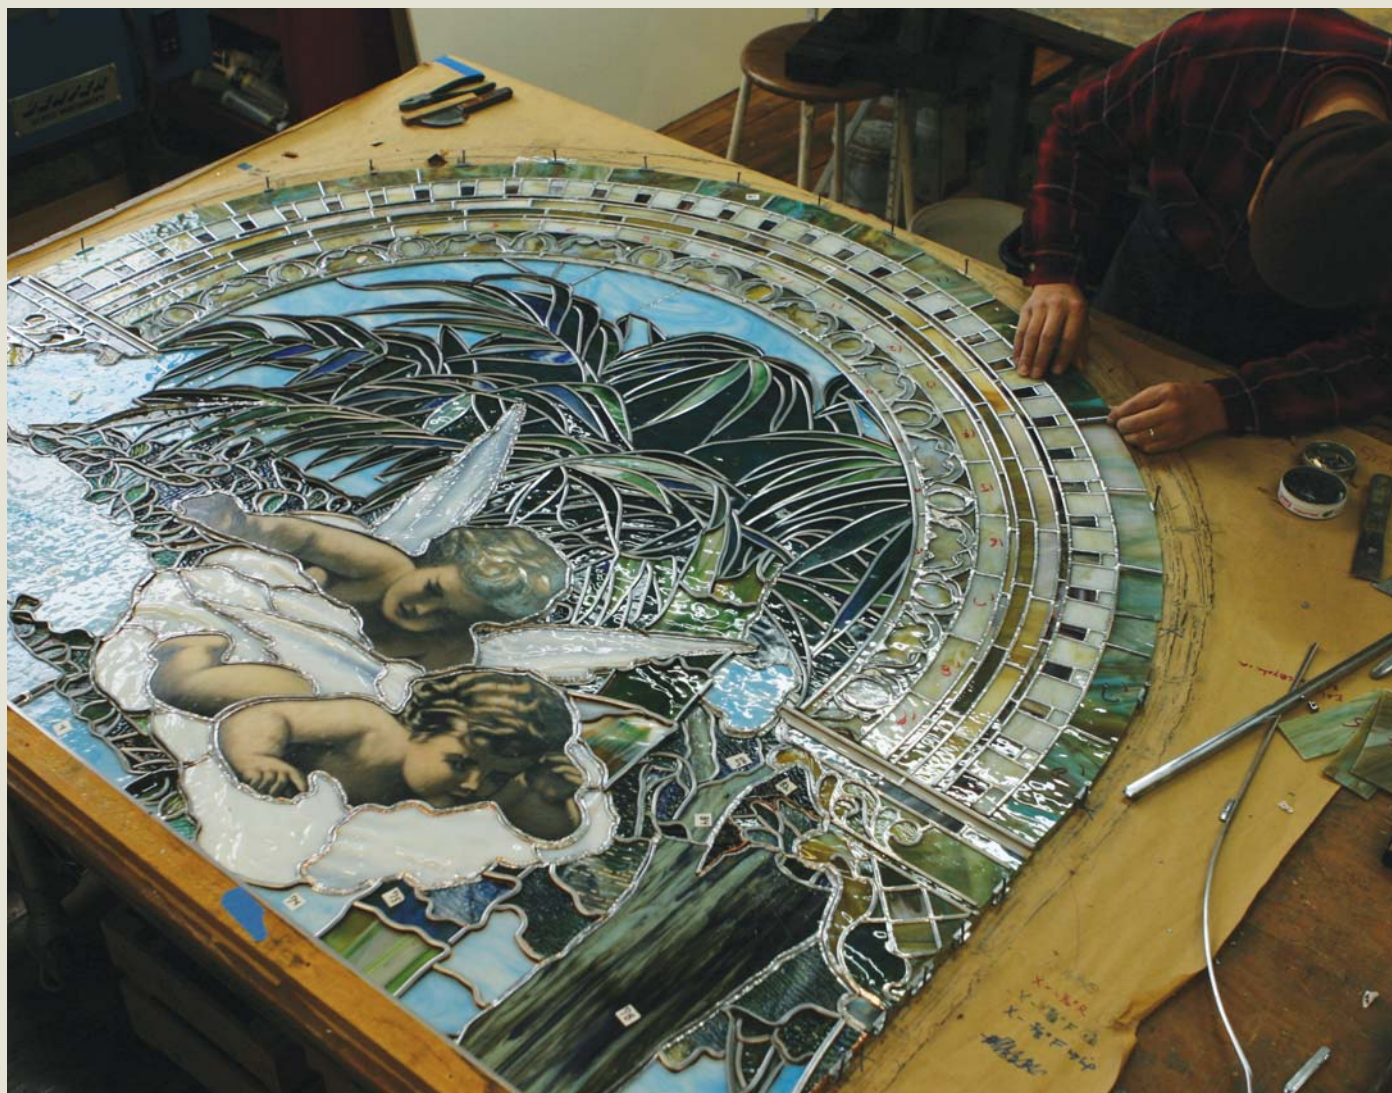
Takuji Hamanaka glazing the large top section on **The Flight into Egypt**.

Glazing these complex windows was extremely challenging, especially with Lamb’s penchant for fragile cuts, interlocking shapes, and large pieces of glass. The narrow bands in the top arches on all three windows have numerous hand-cut lead inlays, so it was decided to preserve the original lead work in this one place, since doing so would not affect the stability of the window. All other leads were replaced.

Frames often catch just  $\frac{3}{8}$ ” of a panel’s edge on each side, with an additional  $\frac{1}{8}$ ” for movement. The three bottom

sections in all three windows were cut smaller than those above them. If glazed tightly they would be  $\frac{1}{2}$ ” smaller than the others, so they needed to be “spread” to gain the extra  $\frac{1}{2}$ ” in width. Small pieces of steel bar were inserted to build out the size without weakening the panel. The top sections were all short and needed to be built out at the top of the arch with extra lead came to reach the frame. Lead alone is malleable and easily moves out of plane, so the window was built out with clear glass covered with lead to provide structure while reaching the necessary size.
